**Maryland Historical Trust
State Historic Sites Inventory Form**

Survey No. WA-II-1127

historic ROSEMONT

ROSEMONT

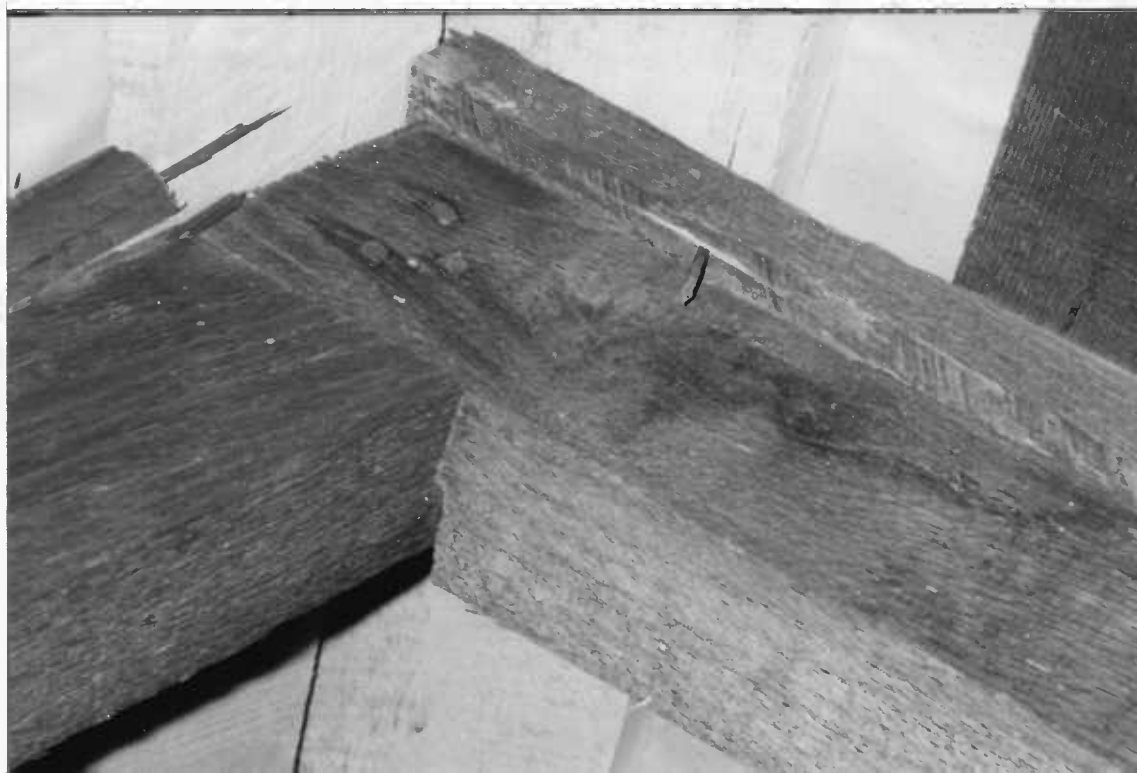
The roof of the main block consists of large sawn rafters half-lapped and triple nailed with cut nails at the apex. The rafter pairs are marked with Roman numerals. The back side of the original beaded clapboards is visible in the gables. A section of these clapboards was also reused along the attic interior of one gable end. The original attic stair was cut through three joists at the north end of the house. The whitewashed log construction is visible at the east end of the stair. A false chimney top at the upper end of the north gable was built to provide symmetry along the roof line, visually balancing the functional south chimney.

Roof rafter MAIN House
Half Lapped
triple nailed

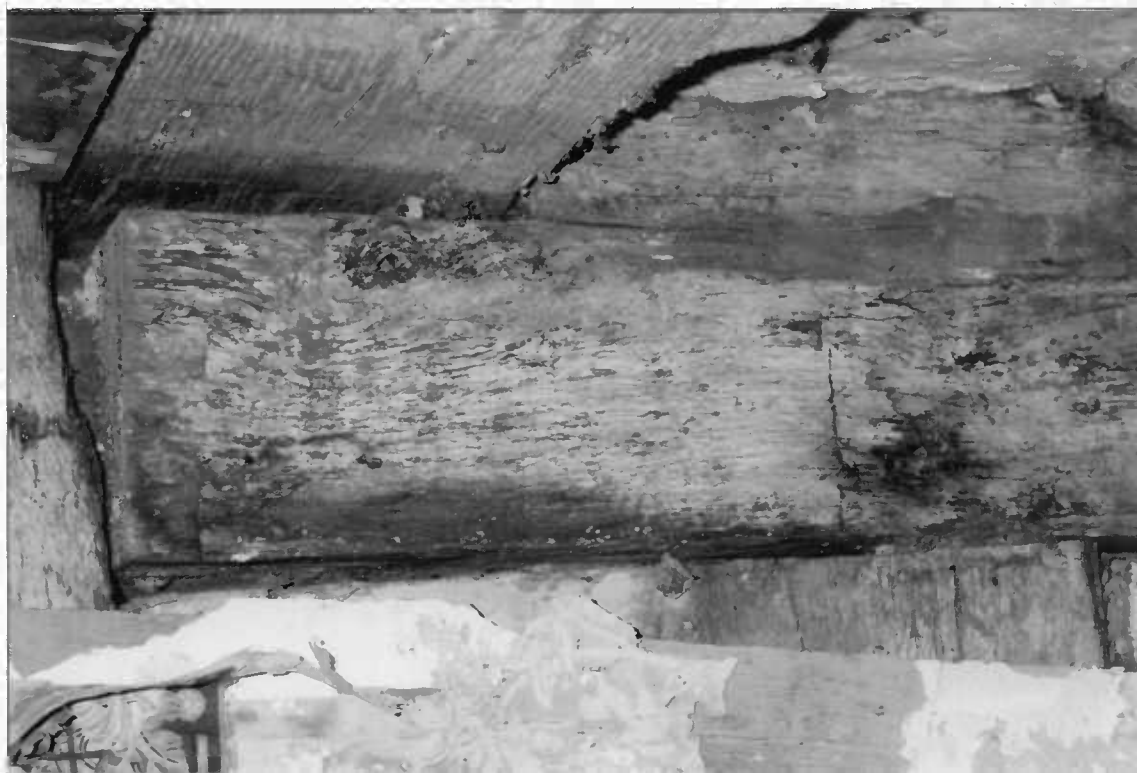
In recent years, the masonry below the main block's south windows was repaired. The log construction that was visible at this time included pegged angle braces. A corner post running the full two stories of the house in the northeast corner is visible under the stair on the first floor as well as in the corner of the stairwell in the attic. The logs appear to be tenoned into the corner post. This log in post construction is similar to that of a building at 201 S. Main St. in nearby Sharpsburg. In this case the structure is fully exposed and whitewashed.

close-up corner post
northeast corner attic

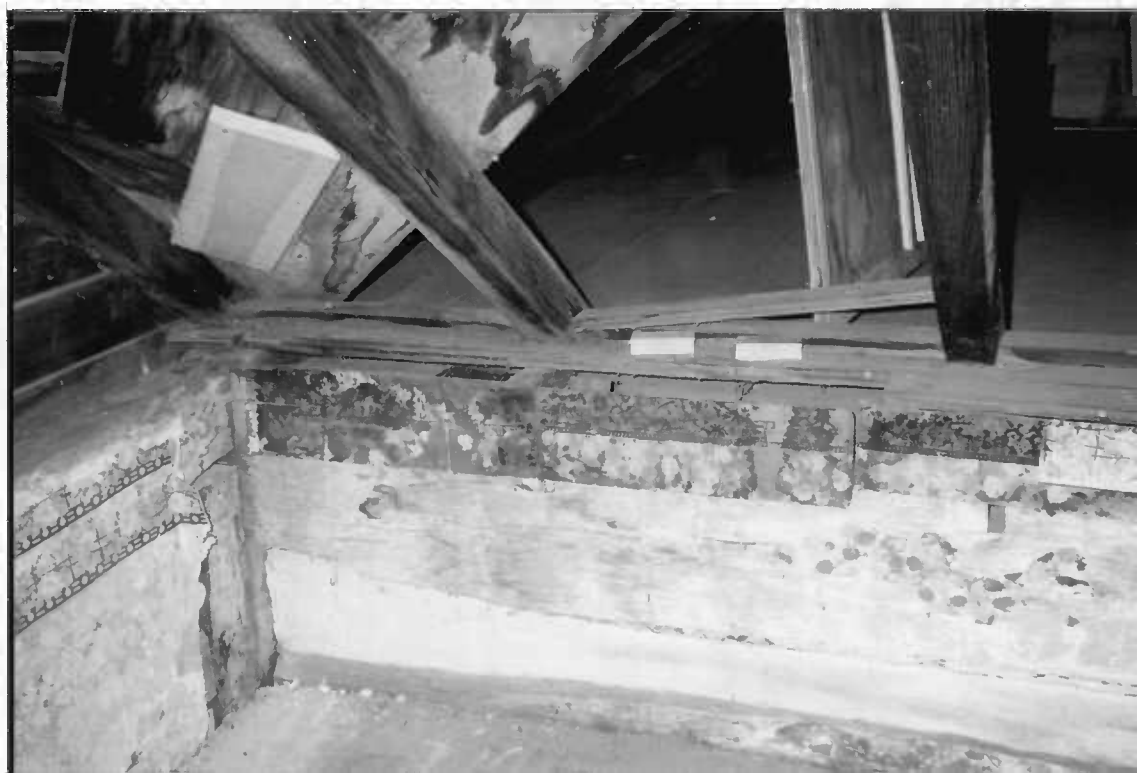
corner post, northeast corner attic
with logs tenoned into it
remnants of ca 1880
wallpaper

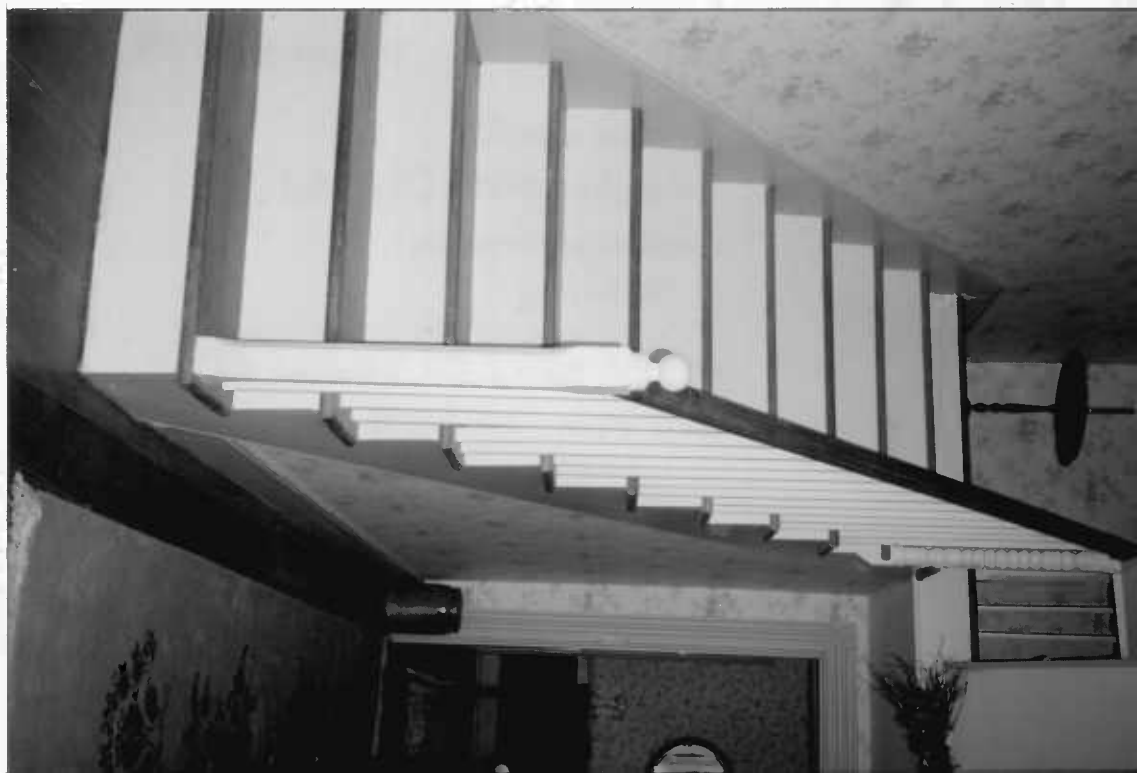
The main stairway rising along the north wall comprises square chamfered newell posts with rounded knob tops, pairs of rectangular balusters, and a rounded handrail. This stair was cut through the floorboards of the second floor, suggesting that it might be of mid-19th century construction, but not original. A fancifully turned post was added to support the corner of the attic stairs.

Front stairs to second floor
entrance hall

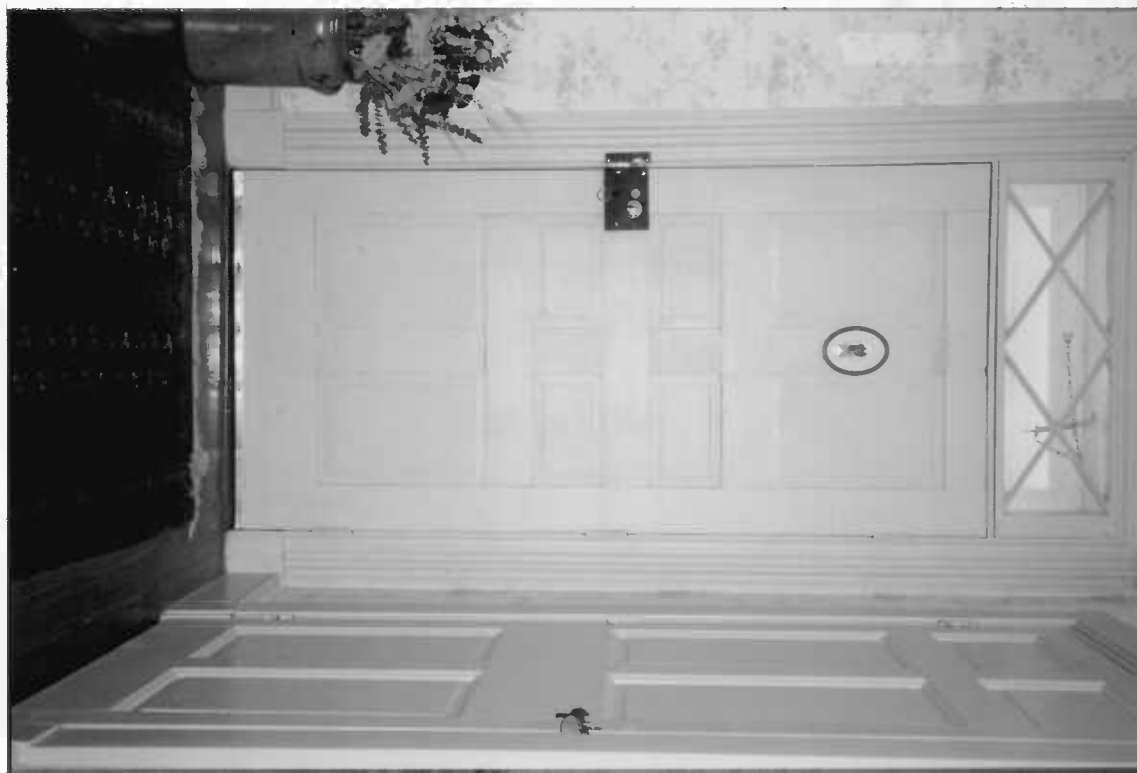
Rosemont's main entrance includes a transom and an eight raised panel door. This door, retrieved from a shed, has been restored to its apparent original position. Four horizontal rectangular panels in the center are adjoined by pairs of rectangular panels top and bottom.

Front door

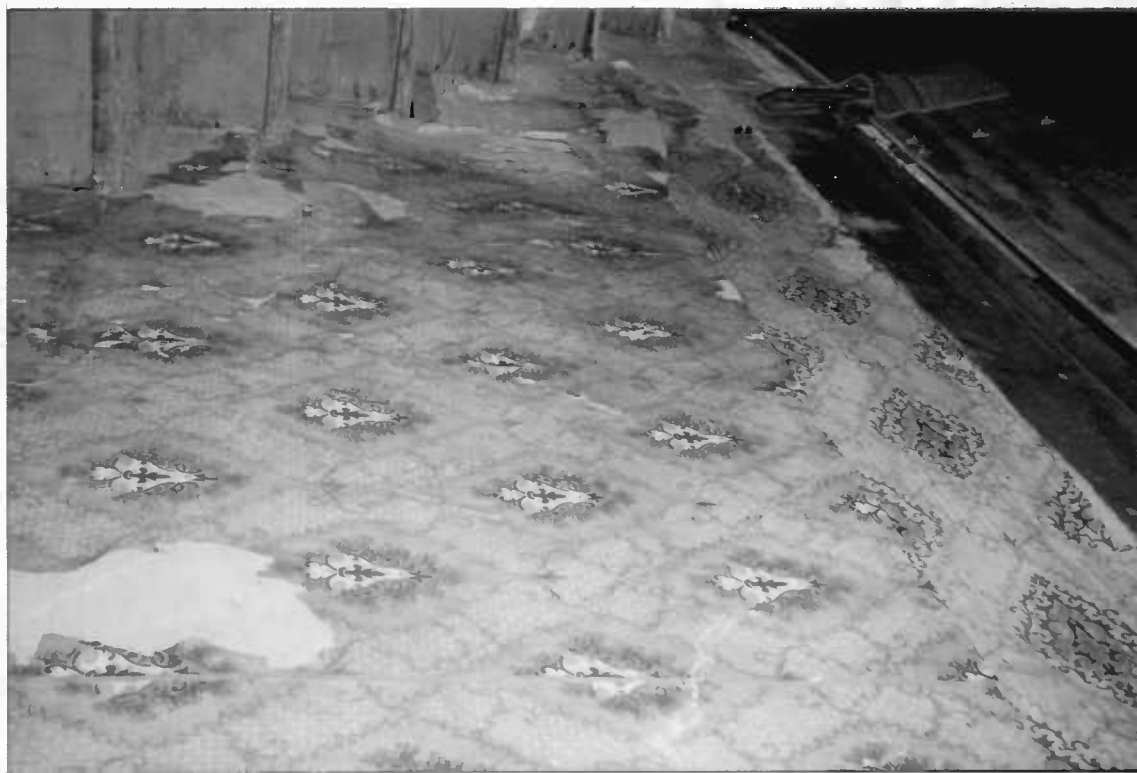
Both the front staircase to the attic and the rear staircase to the attic sidewalls contain several coverings of various wallpaper designs. Photographs of these coverings were provided to the Cooper-Hewitt Museum for dating. The wallpapers in the front staircase were identified as "Anglo-Japanesque" style borders meant to be cut before application-machine printed; c. 1880. The coverings in the back staircase were identified as c. 1895-1910-machine print.

Wallpaper ca 1895-1910
rear stairs to attic
